EVALUATION OF  
CITY OF BOSTON  
PARK AND RECREATION LAND

NEIGHBORHOOD OF NORTH DORCHESTER

Prepared for  
MAYOR'S OFFICE  
OF  
CAPITAL PLANNING

THE HALVORSON COMPANY, INC.  
LANDSCAPE ARCHITECTS AND  
SITE PLANNING CONSULTANTS  
161 MASSACHUSETTS AVENUE  
BOSTON, MASSACHUSETTS 02115

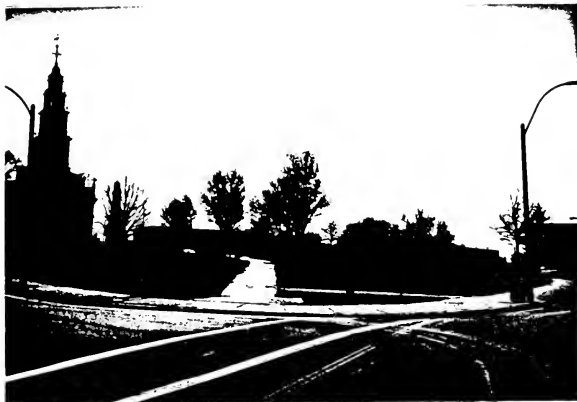
**Site Photograph 1**

View along main access into park from the corner of Adams and Church Streets with planting of Norway Maples. Water fountain given prominent location.

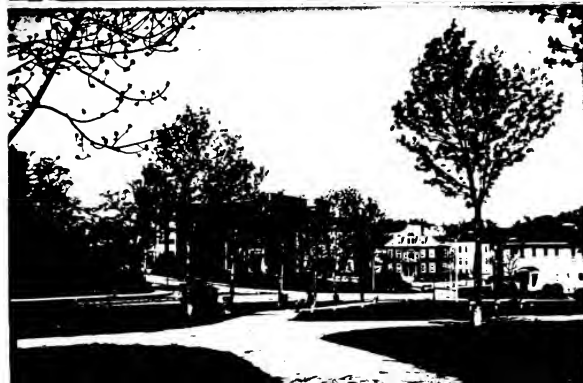
**Site Photograph 3**

View downhill showing seating and shade trees along access route.

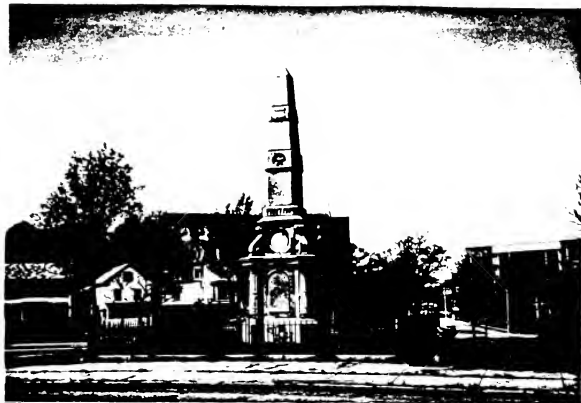
**Site Photograph 4**

Civil war monument - presence as a point of historic and focal importance could be strengthened.

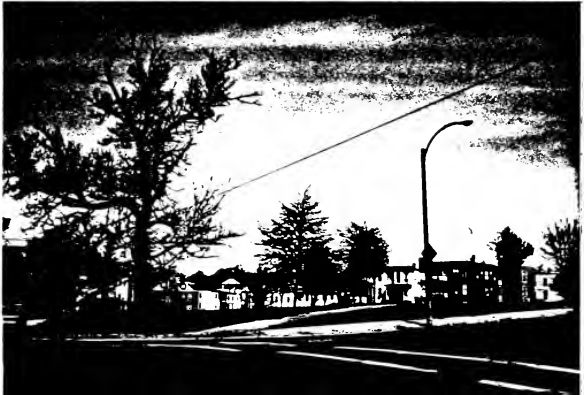
**Site Photograph 6**

View into park from corner of Adams and Winter Streets - entrance into park and edges need to be made stronger.

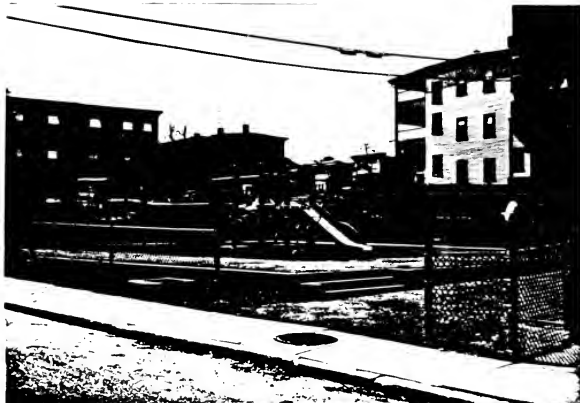
**Site Photograph 1**

Playground constructed  
by adjacent Marr Boys  
and Girls Club.

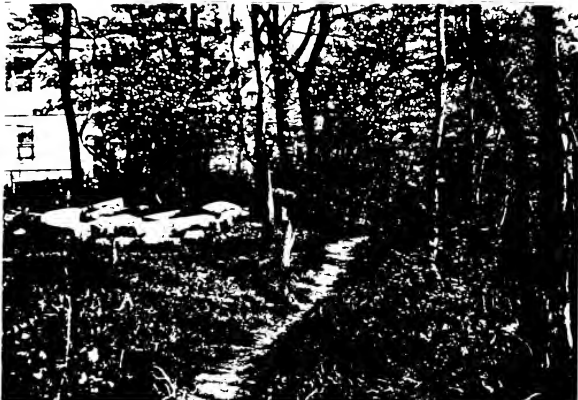
**Site Photograph 1**

Desire lines from adjacent property - a short cut through the site. Granite pieces stock piled on site - difficult to maintain grass around them.

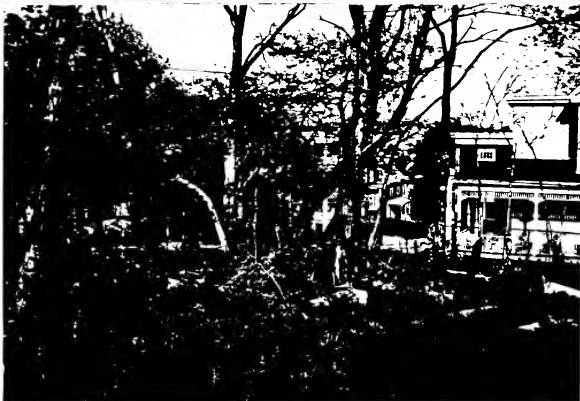
**Site Photograph 2**

Dumping of brush and other debris.

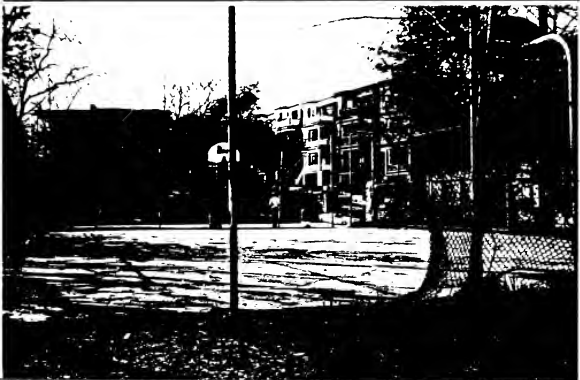
**Site Photograph 3**

Chain link pulled down to allow access through. Fence posts bent. No hoop on basketball court.

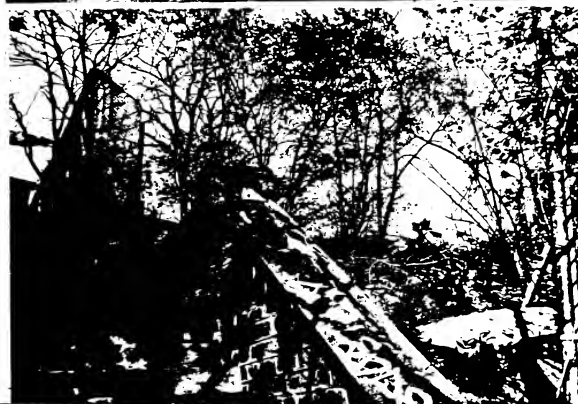
**Site Photograph 9**

View into site from adjacent stairs. Fence unnecessary along top of wall. Barbed wire present in some areas.

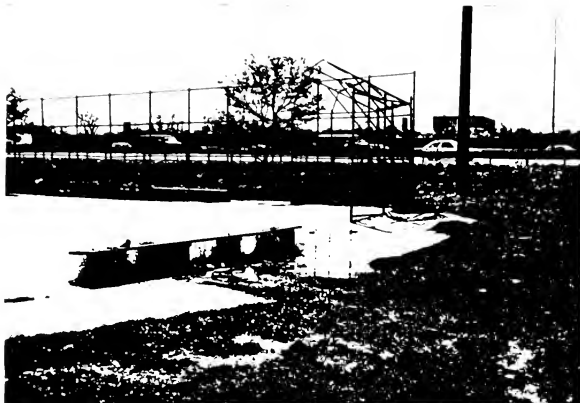
**Site Photograph 1**

Percolation of  
sports field poor -  
ponding of water.

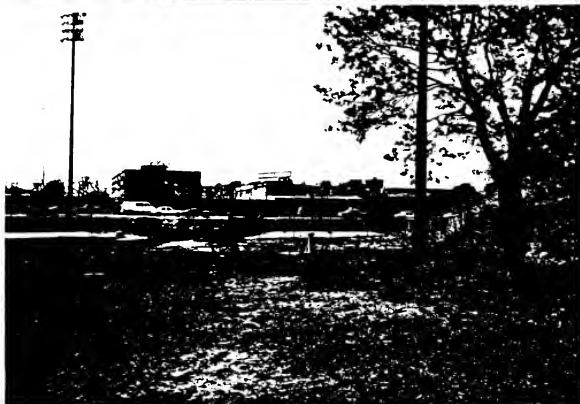
**Site Photograph 2**

View along inside edge  
by Springdale Street -  
poor grass growth.  
Use of enclosed area  
unclear.

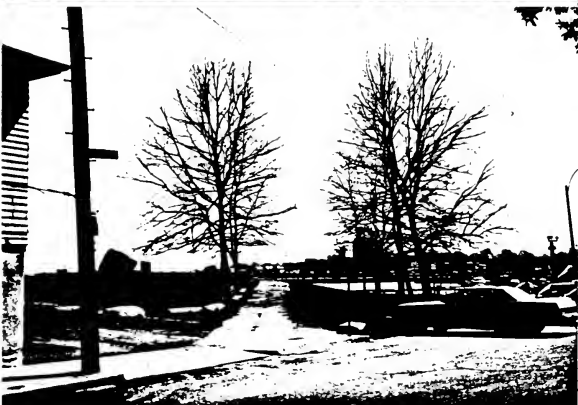
### Site Photograph 9

Pedestrian access from Denny Street. Trees growing well in grassed area.

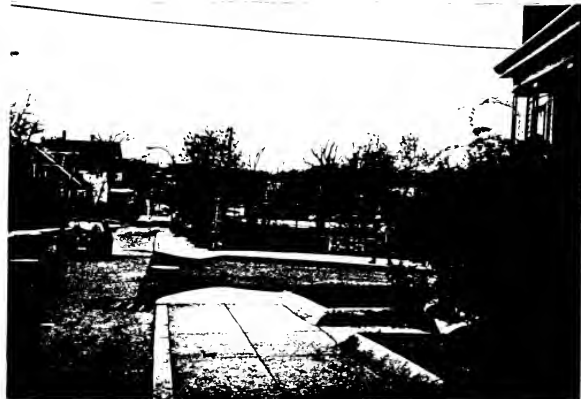
**Site Photograph 2**

Entrance into park from Quincy Street.

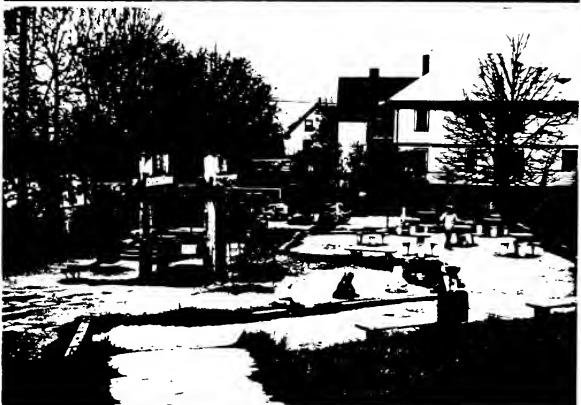
**Site Photograph 3**

View across playground showing layout of area. Safety surface needs weeding and replenishment.

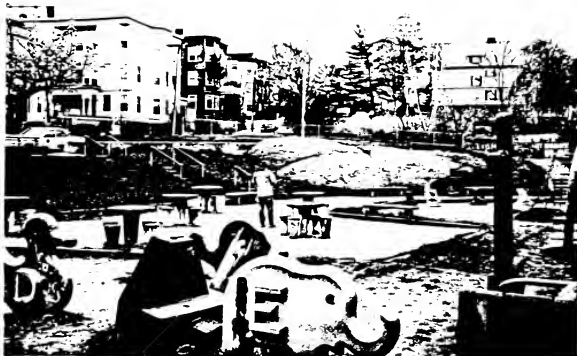
**Site Photograph 4**

Rock outcropping adds character to site.

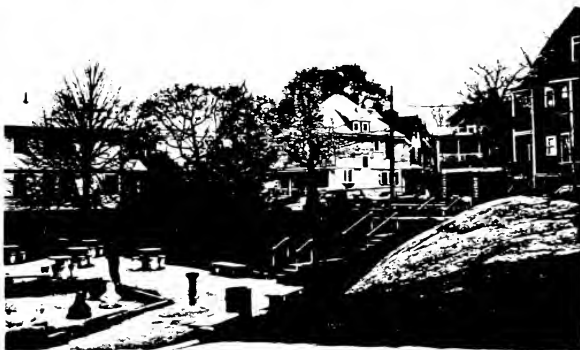
**Site Photograph 5**

Sloped grassed edge used for active free play.

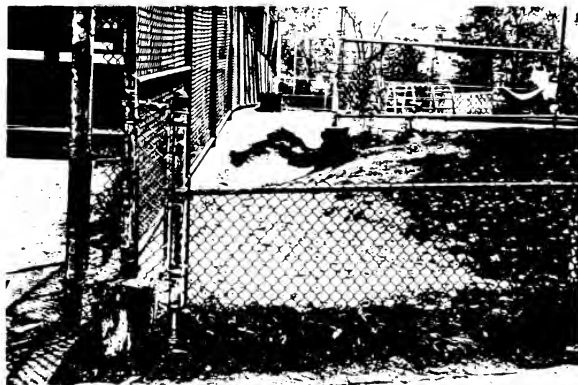
**Site Photograph 5**

Short cut and access  
 point at this corner -  
 an erosion problem.

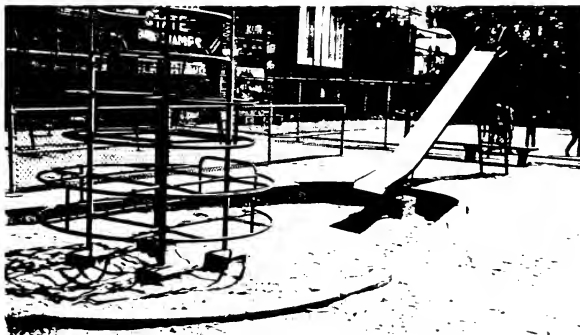
**Site Photograph 6**

Sand level too low,  
 exposed concrete  
 footings.

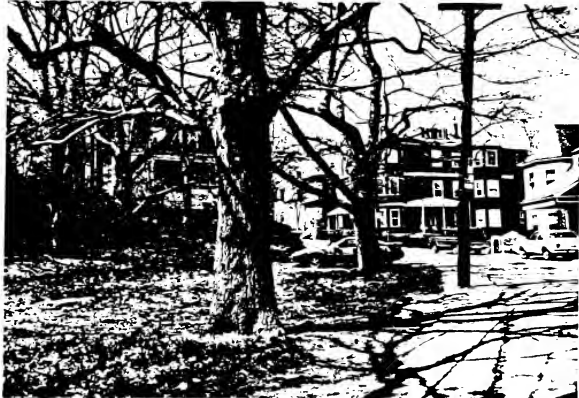
**Site Photograph 4**

No curb along Grampian Way - cars parking under trees and compacting soil in tree root zone.

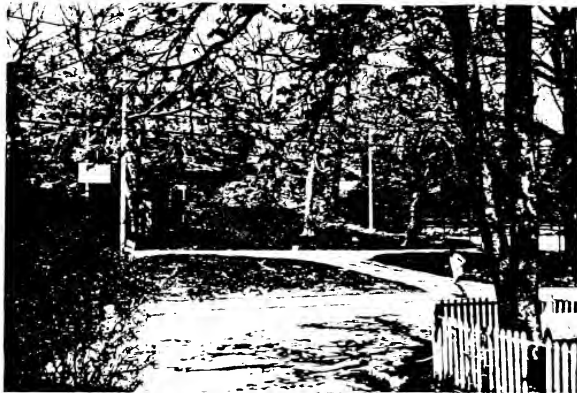
**Site Photograph 7**

Entrance from Grampian  
Way to tennis courts.

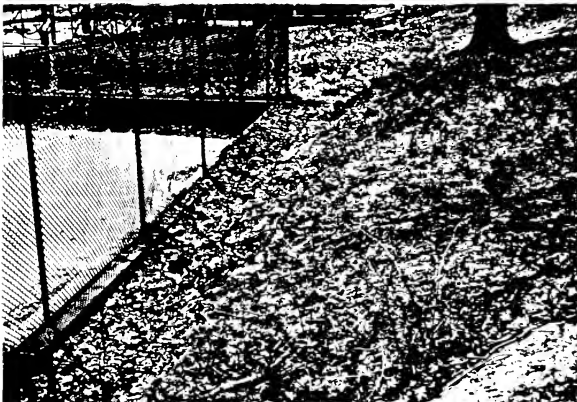
**Site Photograph 8**

Trash and litter  
build-up at back of  
courts.

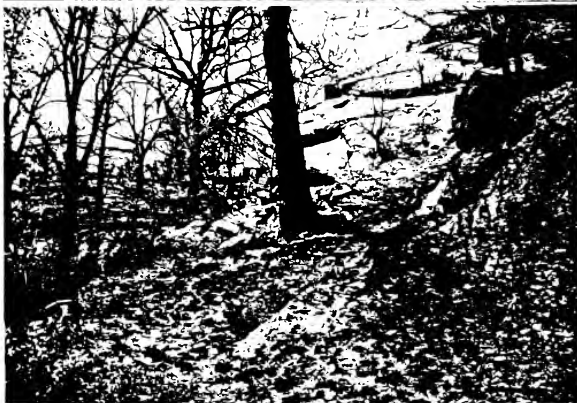
**Site Photograph 9**

Informal walkway around  
site.

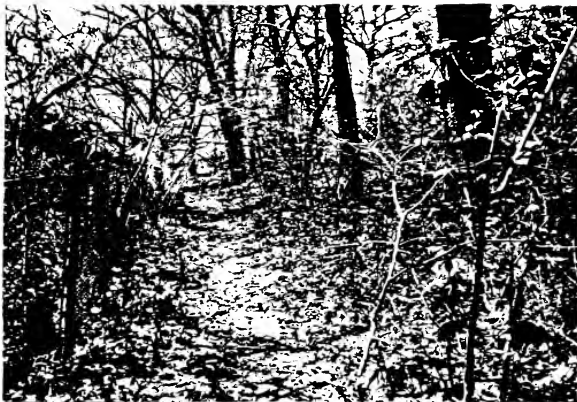
**Site Photograph 10**

Alpine Way once paved, but now very overgrown. Has potential of being important supervision access through site.

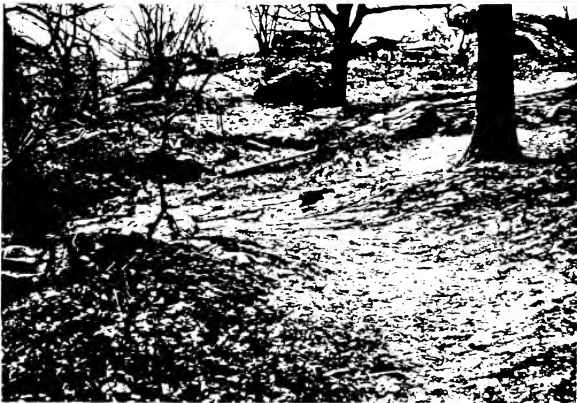
**Site Photograph 11**

Erosion of pathway due to over use.

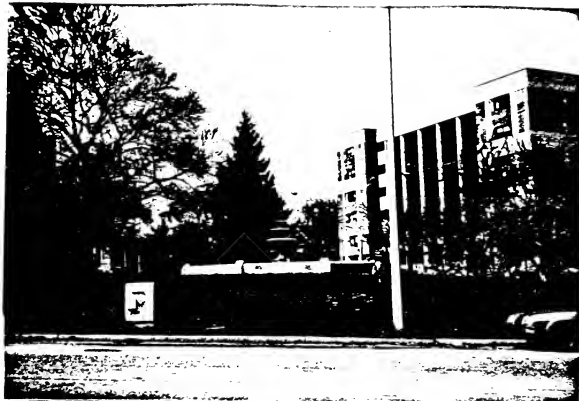
**Site Photograph 1**

View from Adams Street showing mature trees and shrubs and fountain as focal point.

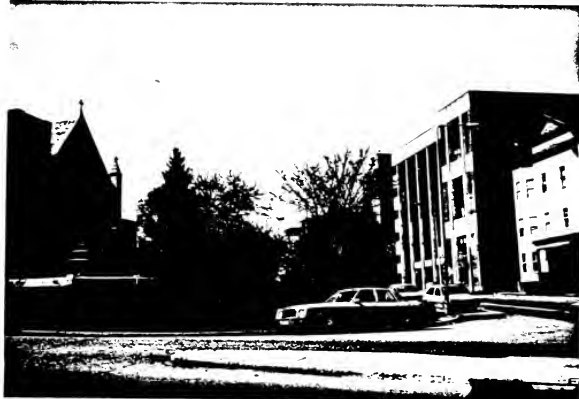
**Site Photograph 2**

Flowering and evergreen shrubs in need of restoration. Cars parked around edges detract from impact of square as an important green space.

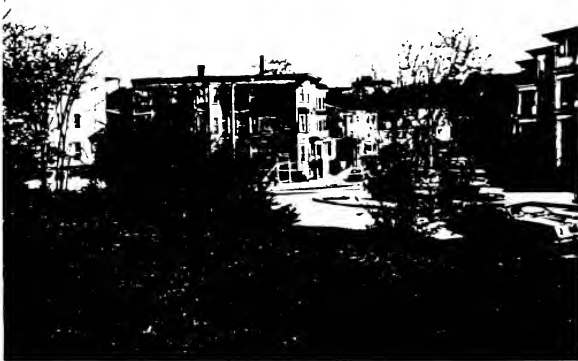
**Site Photograph 6**

Trees and shrubs need renovative pruning. Grass needs improved mowing around base of trees and edges of shrub beds.
